The Major Cause of Earthquake Disasters: Shear Bandings

Tse-Shan Hsu

Abstract

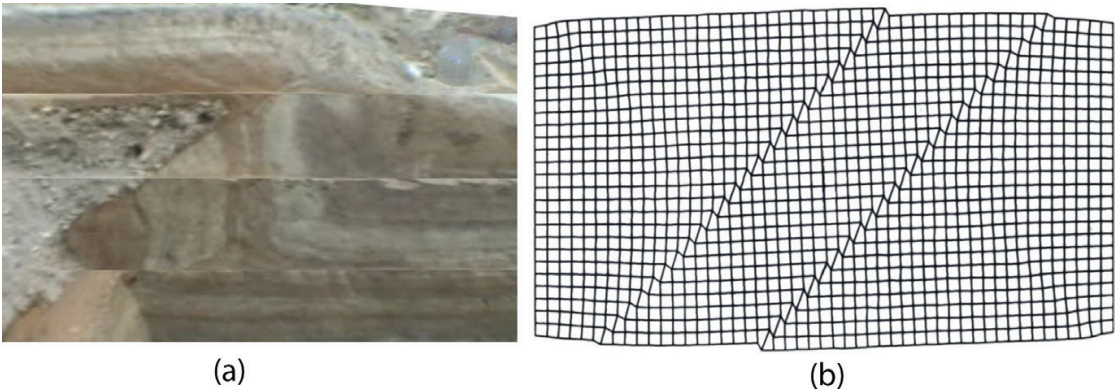
Figure 1. An actual shear band and numerical simulation results [8]: (a) an actual shear band that occurred in Zhushan, Taiwan, during the 921 Jiji earthquake; (b) shear bands produced by the finite element method.

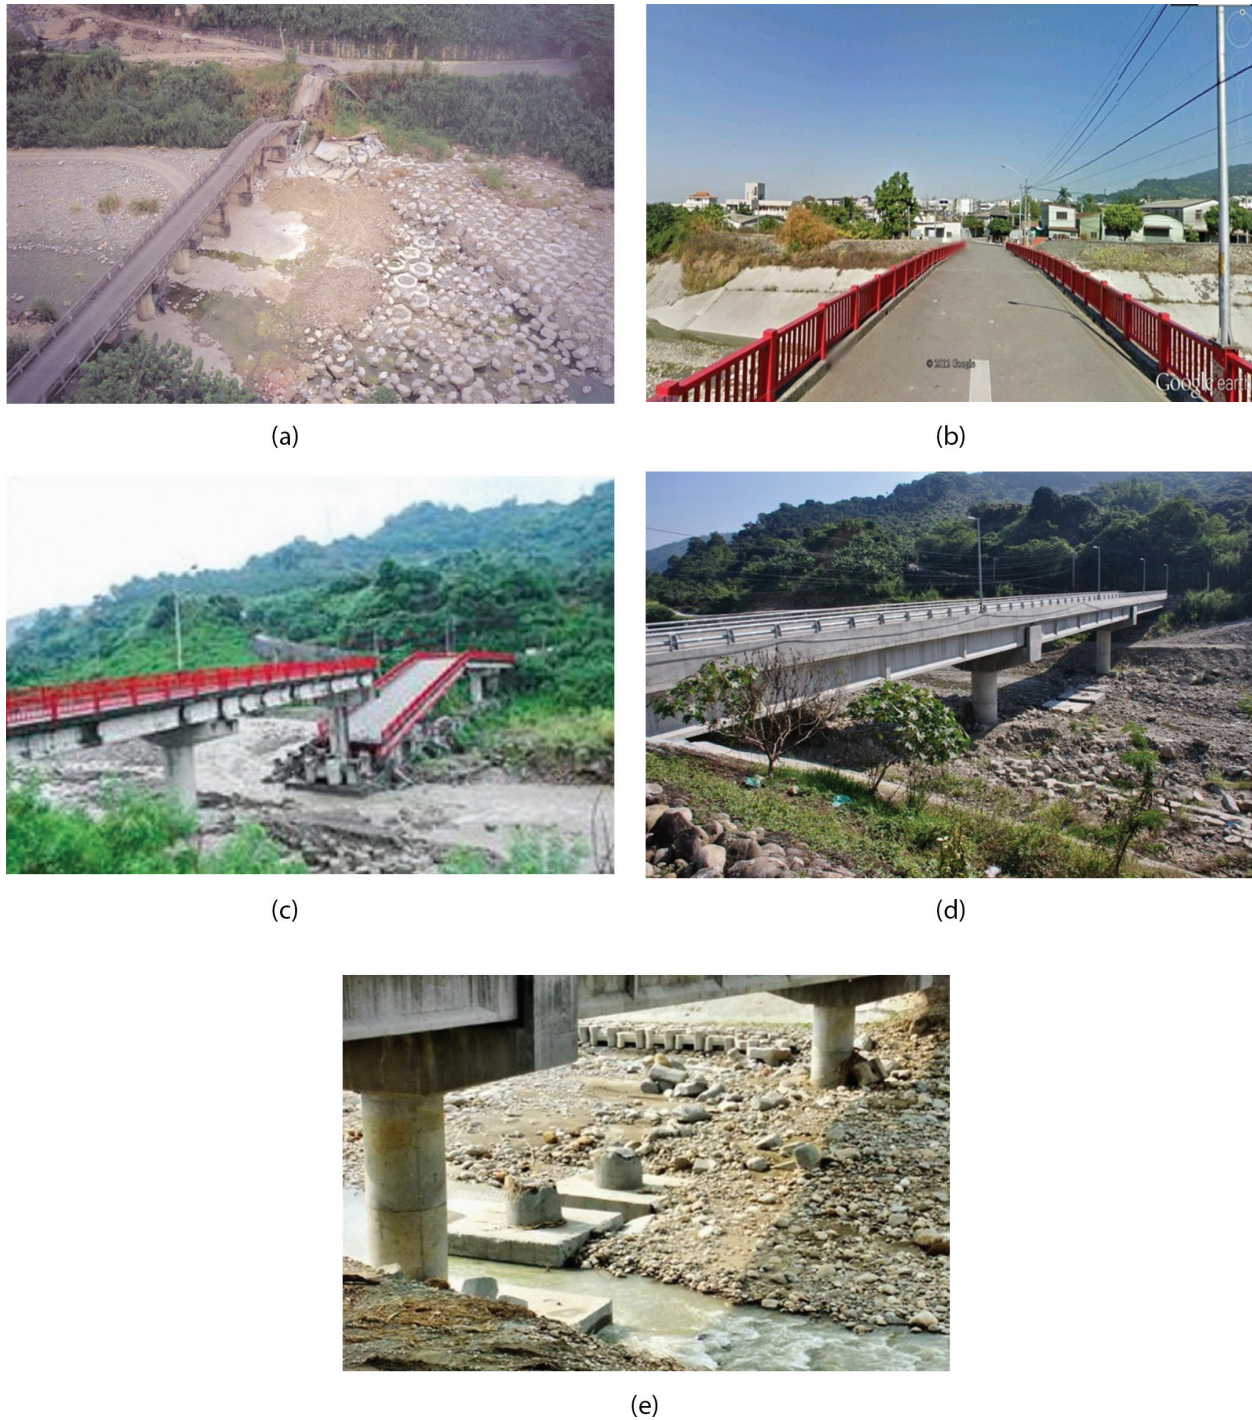
Figure 5a shows the Jianmin bridge which collapsed during the Jiji earthquake. **Figure 5b** shows the rebuilt bridge in 2001 using the new seismic zone division updated in 1999. During Typhoon Fanapi in 2010, the new bridge collapsed again (details in **Figure 5c**). **Figure 5d** shows that the bridge was rebuilt again in 2012 using the new seismic zone divisions updated in 2005. **Figure 5e** shows the exposed pile cap of the bridge only two months after reconstruction.

Figure 5. History of the Jianmin bridge in Taichung, Taiwan: (a) bridge collapsed during the Jiji earthquake, 1999 [10]; (b) bridge rebuilt in 2001 [11]; (c) bridge collapsed again in 2010; (d) bridge rebuilt again in 2012; (e) the exposed pile cap of the bridge [12].

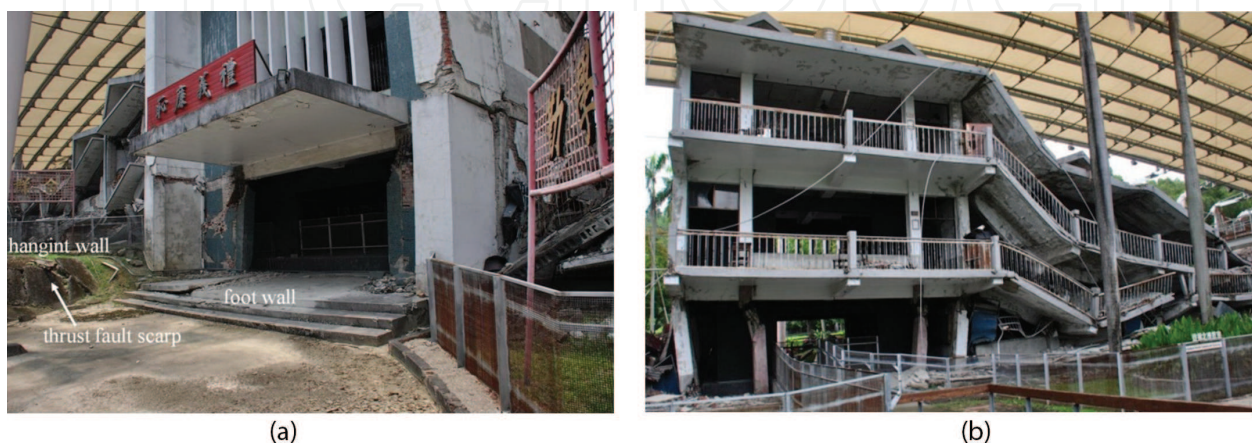
After the 921 Jiji earthquake, Kuangfu Junior High School in Taichung was maintained as an earthquake memorial museum for shear banding, ground uplift, and school building collapse, thereby, preserving the historical facts of the earthquake and providing students and the public educational earthquake material. In 2001, the school was renamed as the 921 Earthquake Education Park. Although the establishment of the museum is well intentioned, the explanations within the museum do not discuss the primary effect, and thus it is difficult to achieve the desired educational function. Taking the Kuangfu Junior High School building as an example, the building collapse is depicted in **Figure 7**. The actual mechanism for such a localized collapse, shown in **Figure 8**, was the occurrence of shear banding during a tectonic earthquake. However, under the guidance of the park instructor, currently, the students and members of the public who have visited consider that the primary cause of the building collapse was the excessive seismic vibration.

Figure 7. The collapse of the Kuangfu junior high school building during the Jiji earthquake: (a) front view; (b) rear view.
